Water Component

Introduction

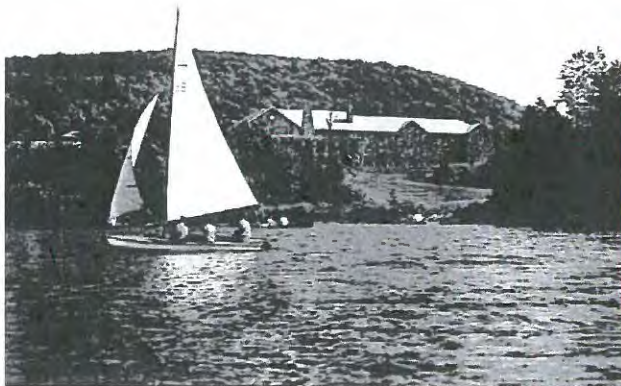
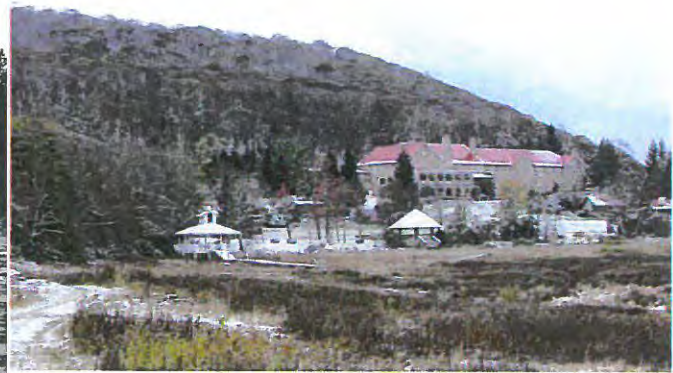
Mountain Lake typically covers about 50 acres, and its level was largely constant at an elevation of 3875 feet during the 19th and 20th centuries. Since 2002, however, it has been subject to significant dry-season level drops. Historically, the last such level fluctuations occurred between 1751 and 1804, with historical accounts giving widely different estimates of the Lake's size. The difference in lake levels can be seen in the images below.

Most recently, several years with no significant refilling of the Lake prompted property management to move forward in 2013 with engineering work to partially plug the drain holes that left the Lake largely dry. Clearly, for property management, there were compelling and practical reasons for the work to be undertaken. Work done in 2013 to limit leakage and promote filling of the Lake has led some stakeholders who contributed to this plan to question its status as a natural lake.
